High-Temperature, High-Bandwidth Fiber Optic Pressure and Temperature Sensors for Gas Turbine Applications

Phase II Air Force STTR – Draft Final Report
Contract #: F49620-03-C-0010

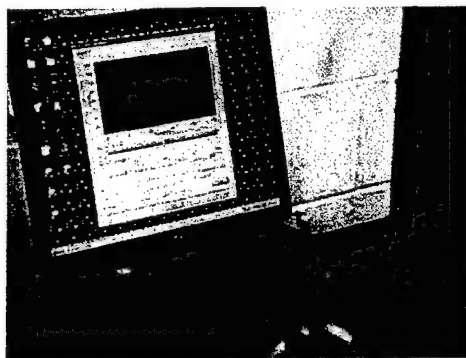
Figure 62: Fringe Contrast of the HTP Sensor

Tests were conducted on a high-temperature pressure sensor. The sensor was constructed with silver paste for the ferrule to Kovar probe bond and solder-glass for the alumina diaphragm to Kovar washer bond. The Kovar washer was welded to the Kovar probe. The limitation was the solder-glass, which has a nominal reheat temperature limit of 800°C. Figure 61 illustrates the test setup. A thermocouple was placed inside the furnace next to the pressure fitting. A second thermocouple was placed on the probe outside the furnace to monitor the probe temperature as shown previously in Figure 58. Figure 60 shows the relative locations of the thermocouples and the sensor tip. This setup allowed for accurate readings to be taken throughout the testing process. Figure 62 shows the sharp fringe contrast of the HT-HP sensor prior to testing.
